St. George Oceanfront Cleanup

- Cleanup to be conducted per Corrective Action Plan (CAP) finalized February 2004
- Estimated 11,200 cubic yards contaminated soil
- TPA Site 1 Former Diesel Tank Farm
- TPA Site 2 Former Drum Storage Area
- TPA Site 3 Inactive Gas Station
- TPA Site 25-1 Port Fuel Supply Line E-W

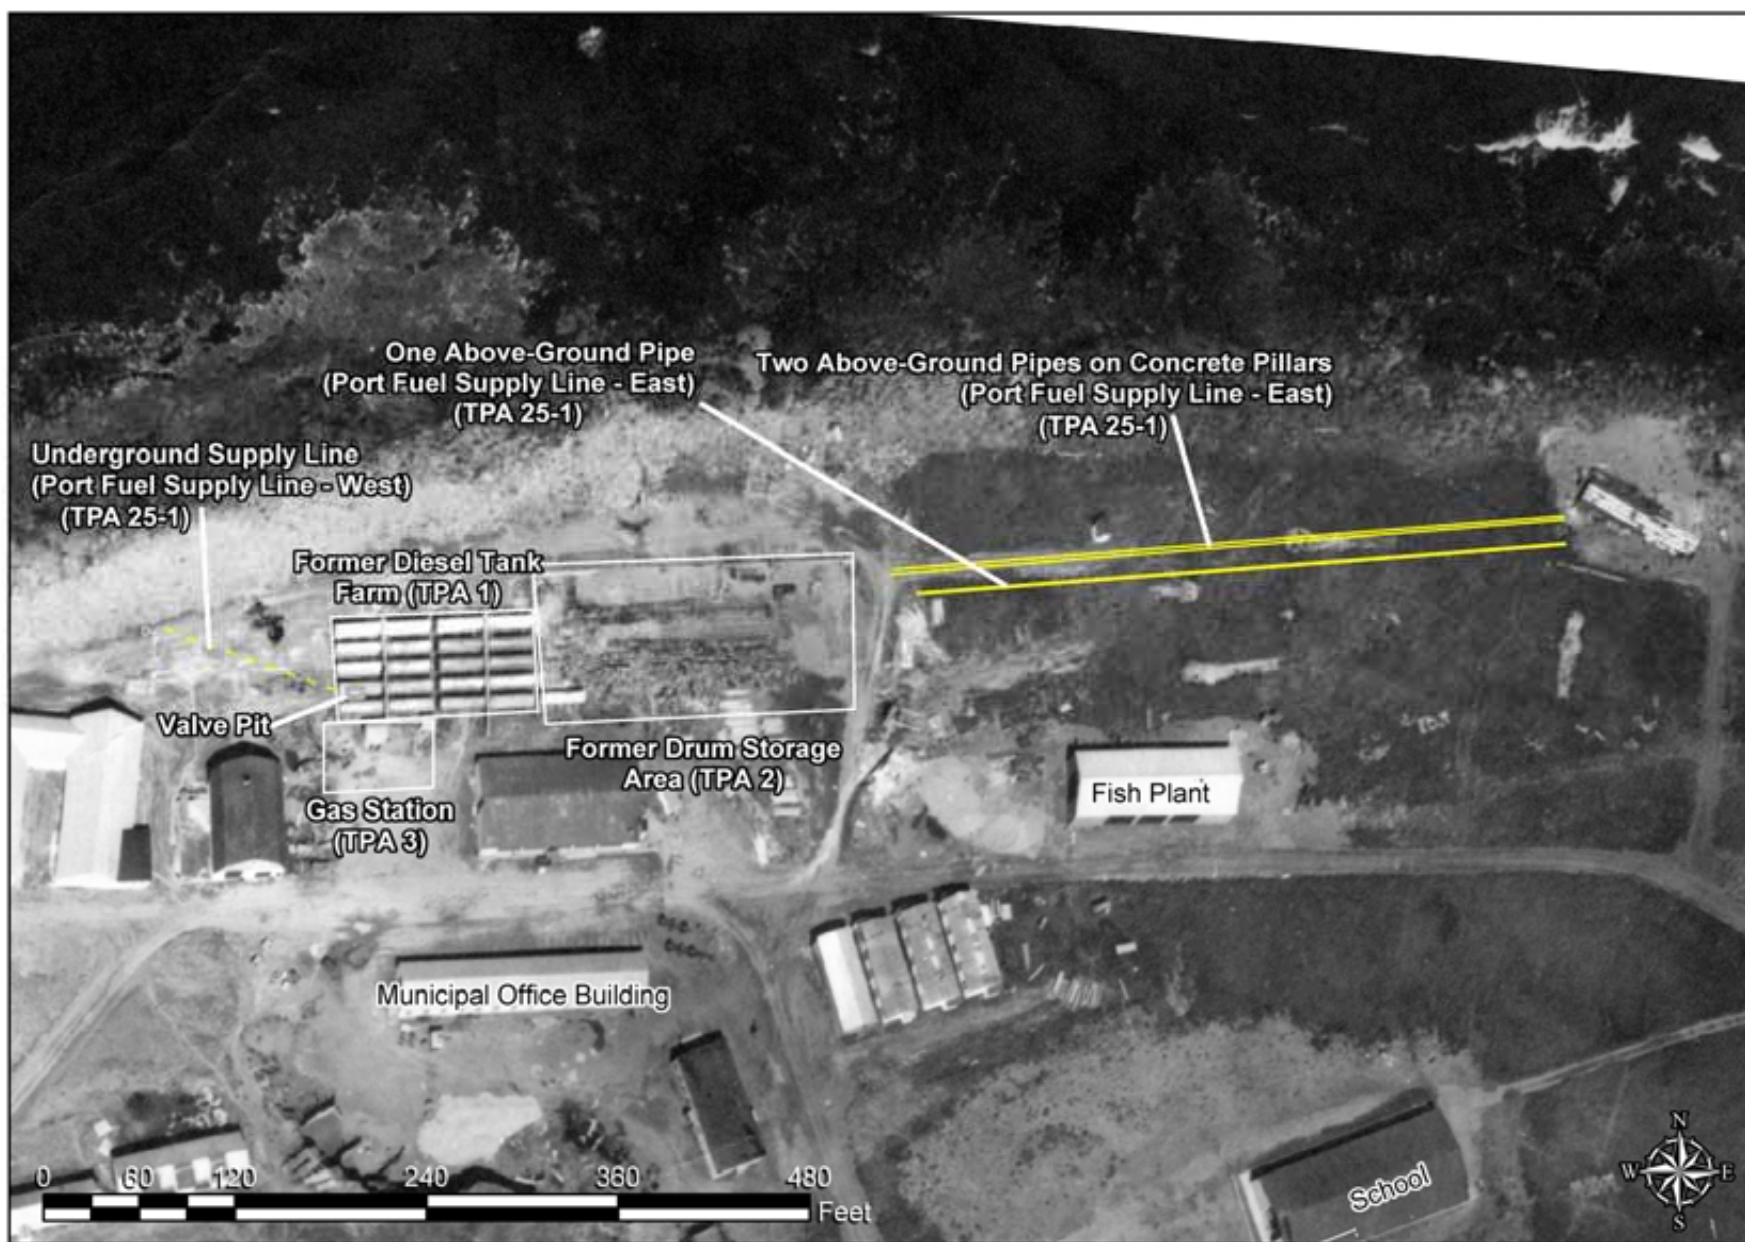
Figure

Oceanfront Sites Overview

Source: Aero Map U.S. 9/28/96
Aerial Photograph; Pribilof Project Database
Note: Approximate Locations of Supply Lines

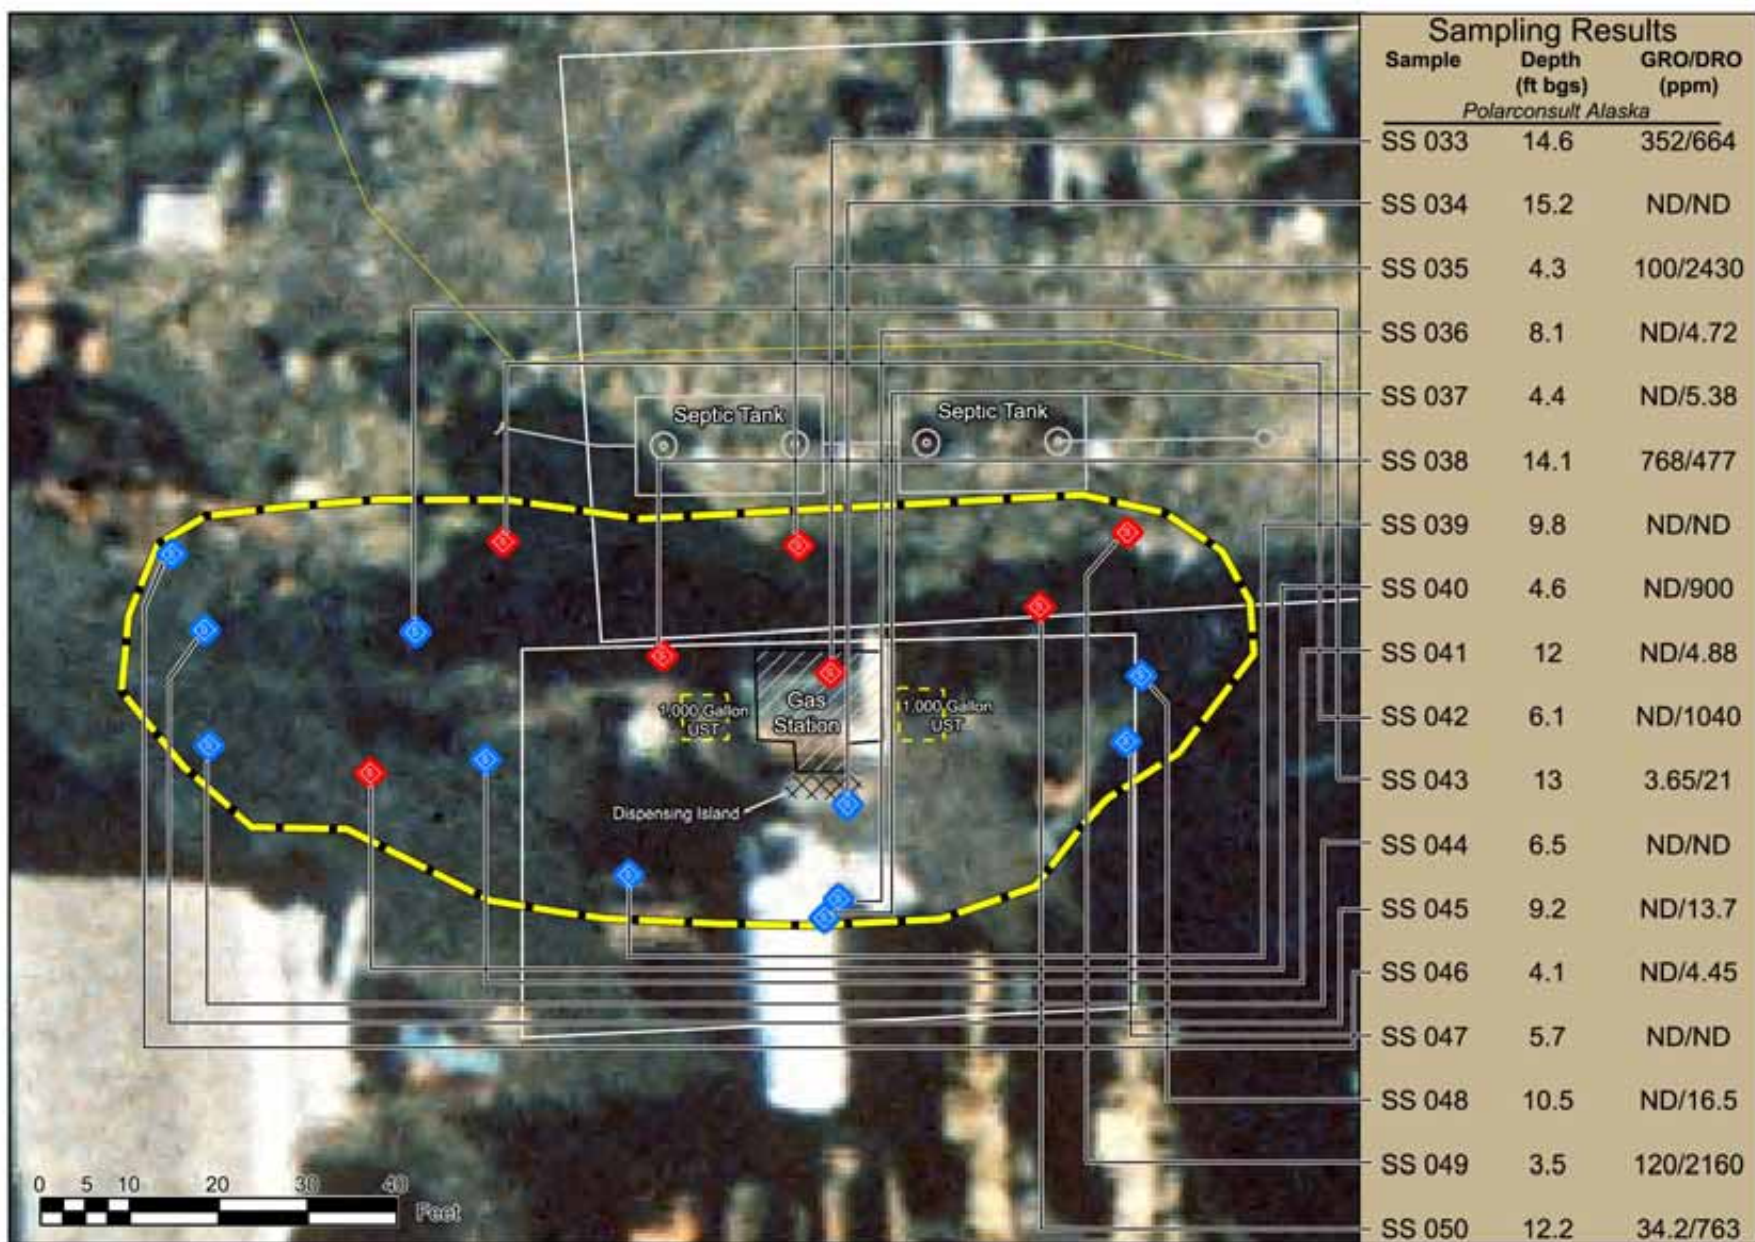
Figure

Oceanfront Sites (Polarconsult 1997 UST Decommissioning)

Source: Aero Map U.S. 9/28/96
Aerial Photograph; Pribilof Project
Database; Polarconsult 1997 St.
George Debris Cleanup & UST
Decommissioning Report

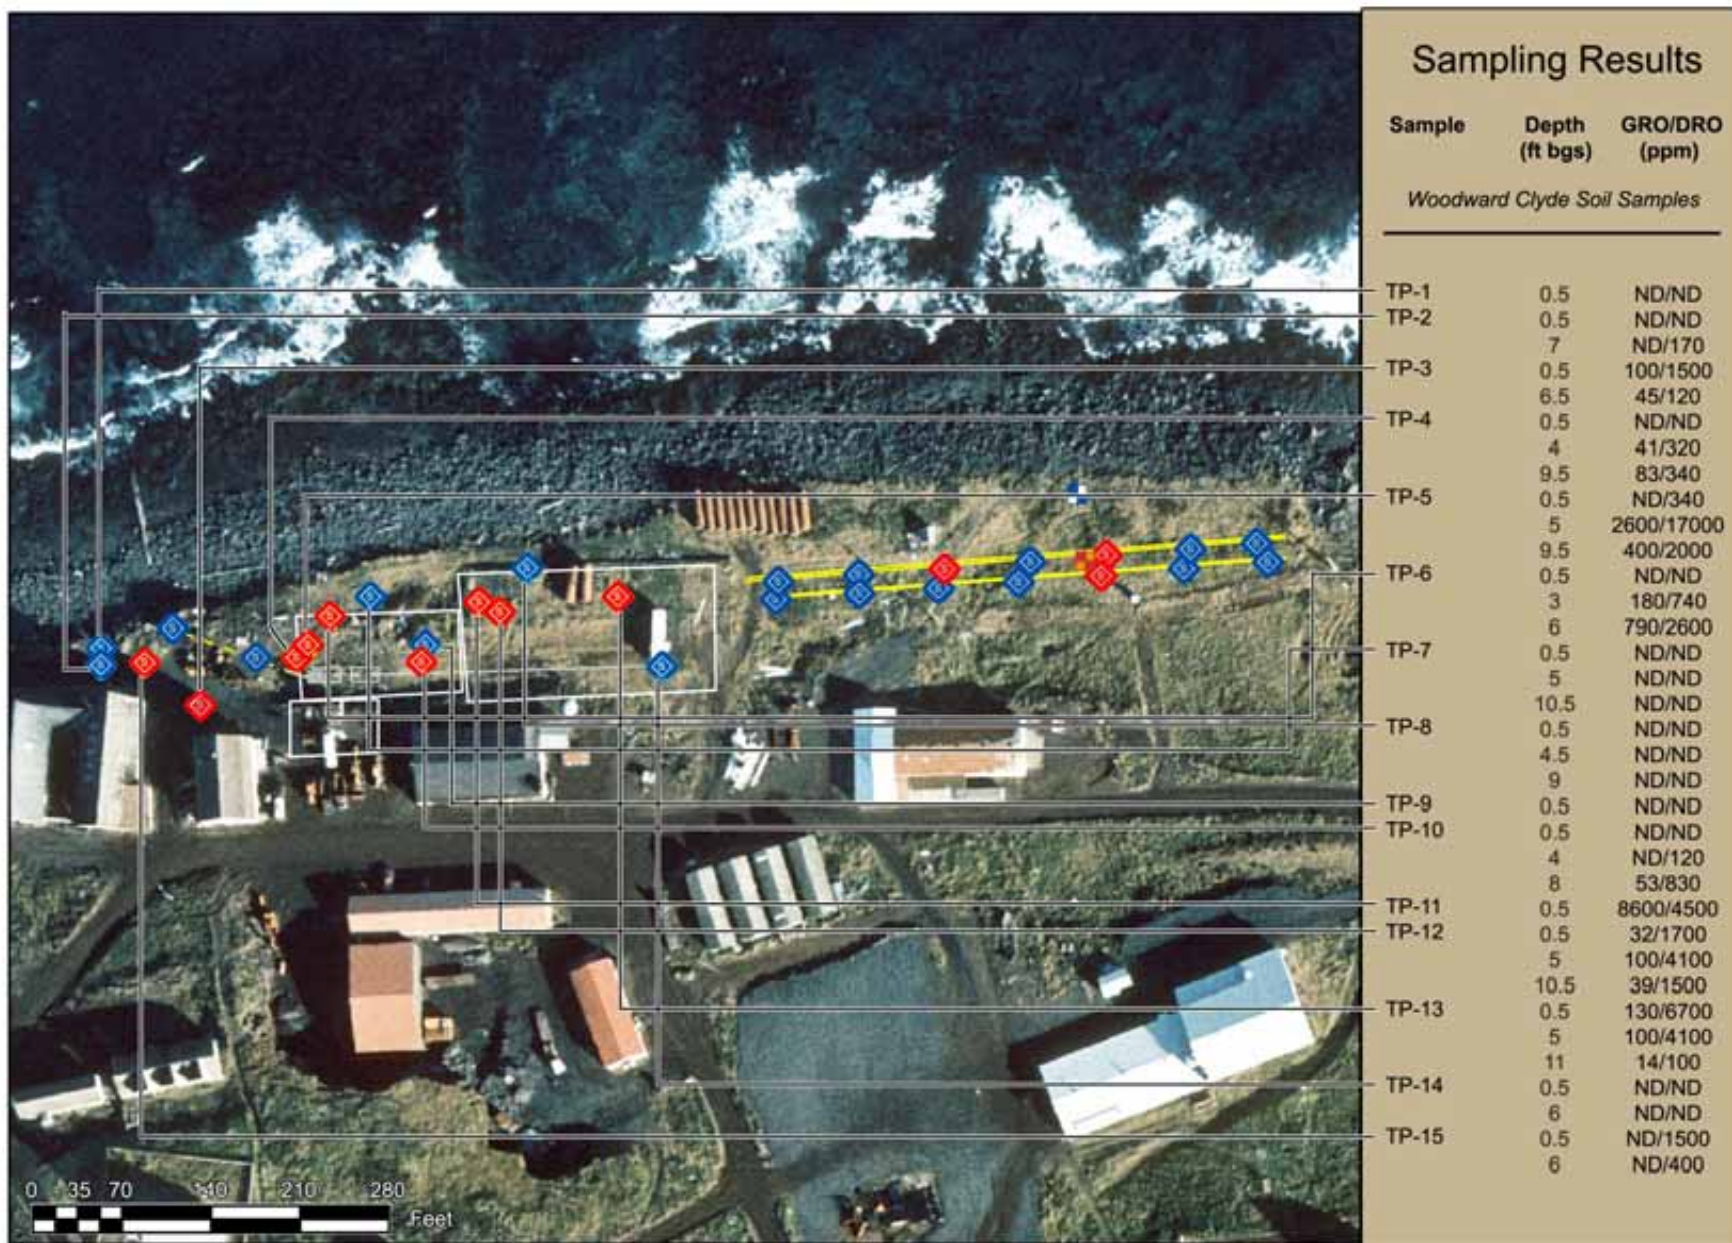
Figure

Oceanfront Sites (Woodward Clyde Characterization)

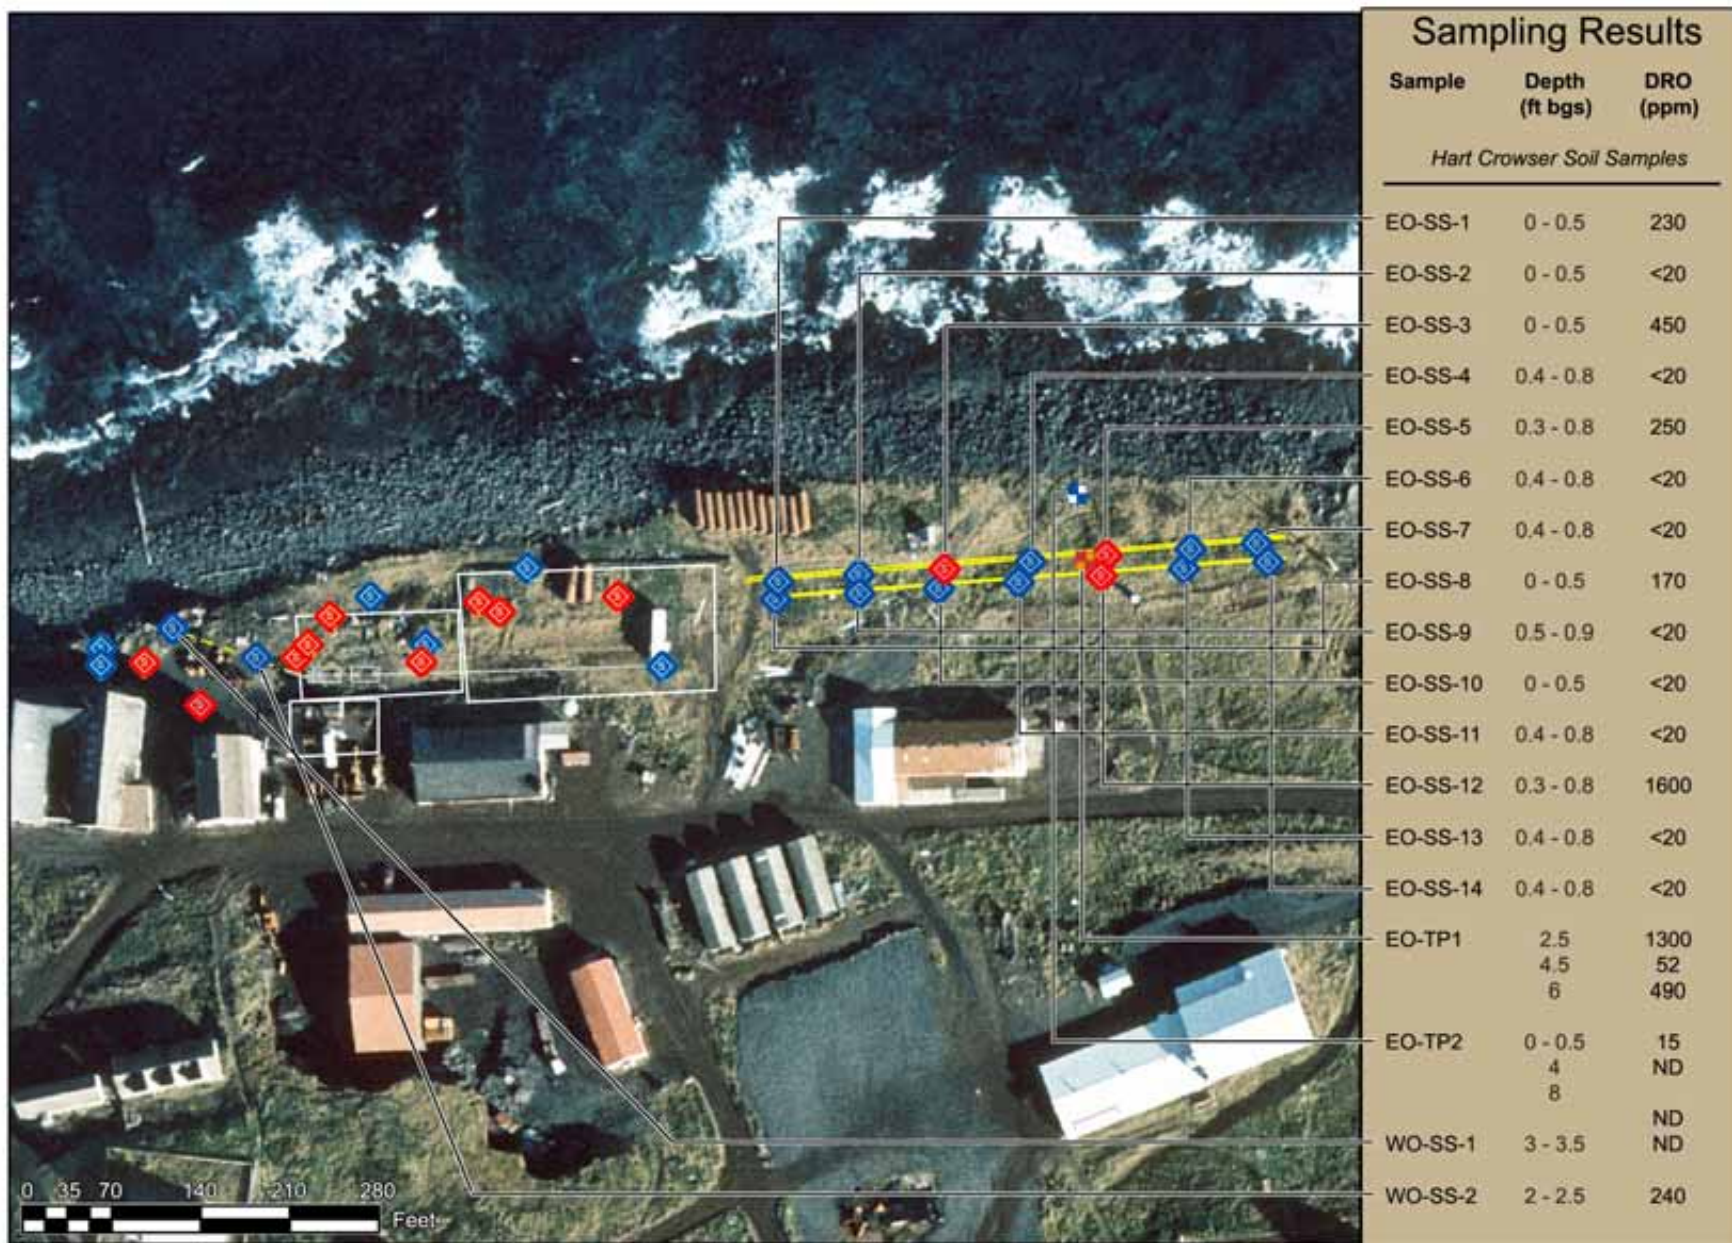
Figure

Oceanfront Sites (Hart Crowser Characterization)

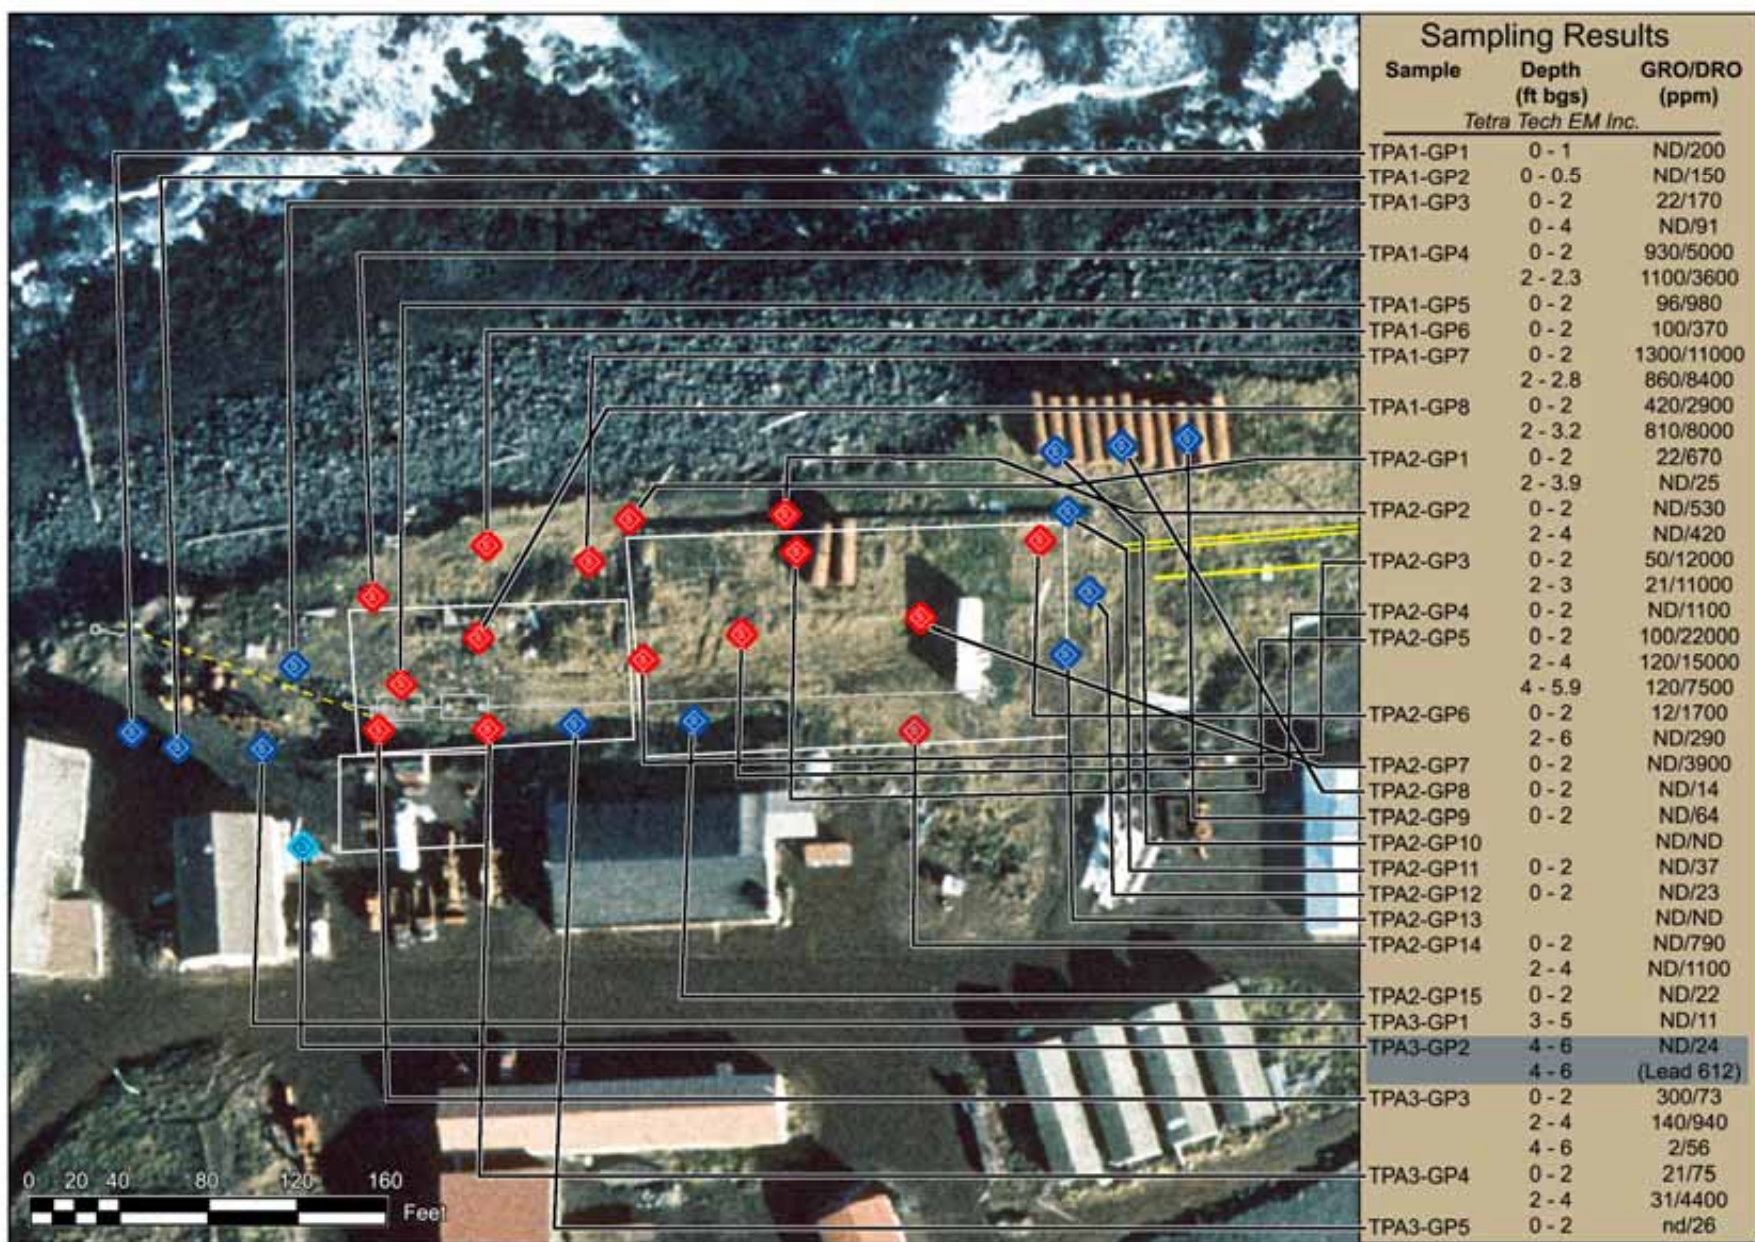
Figure

Oceanfront Sites (Tetra Tech EM Inc. Characterization)

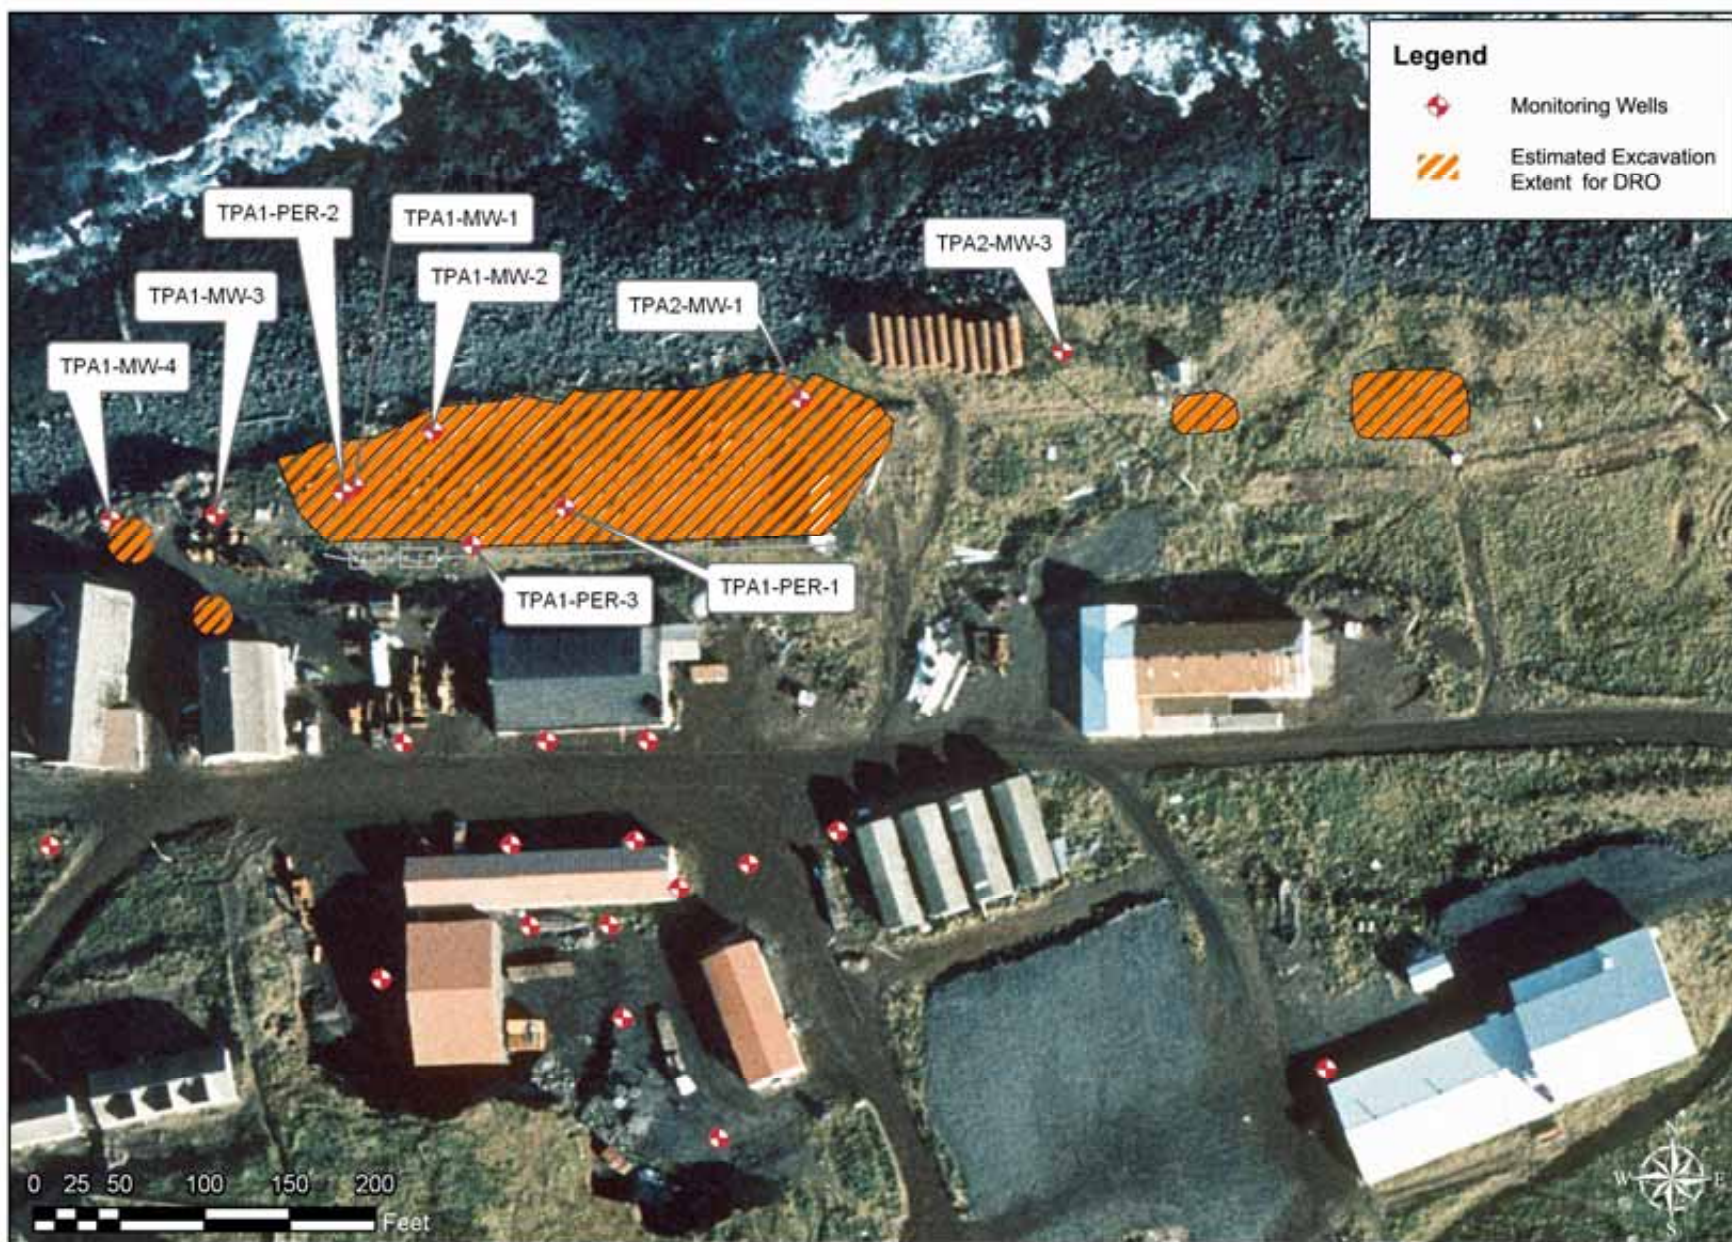
Figure

**Corrective Action SOW
Oceanfront Sites
St. George Island, Alaska**

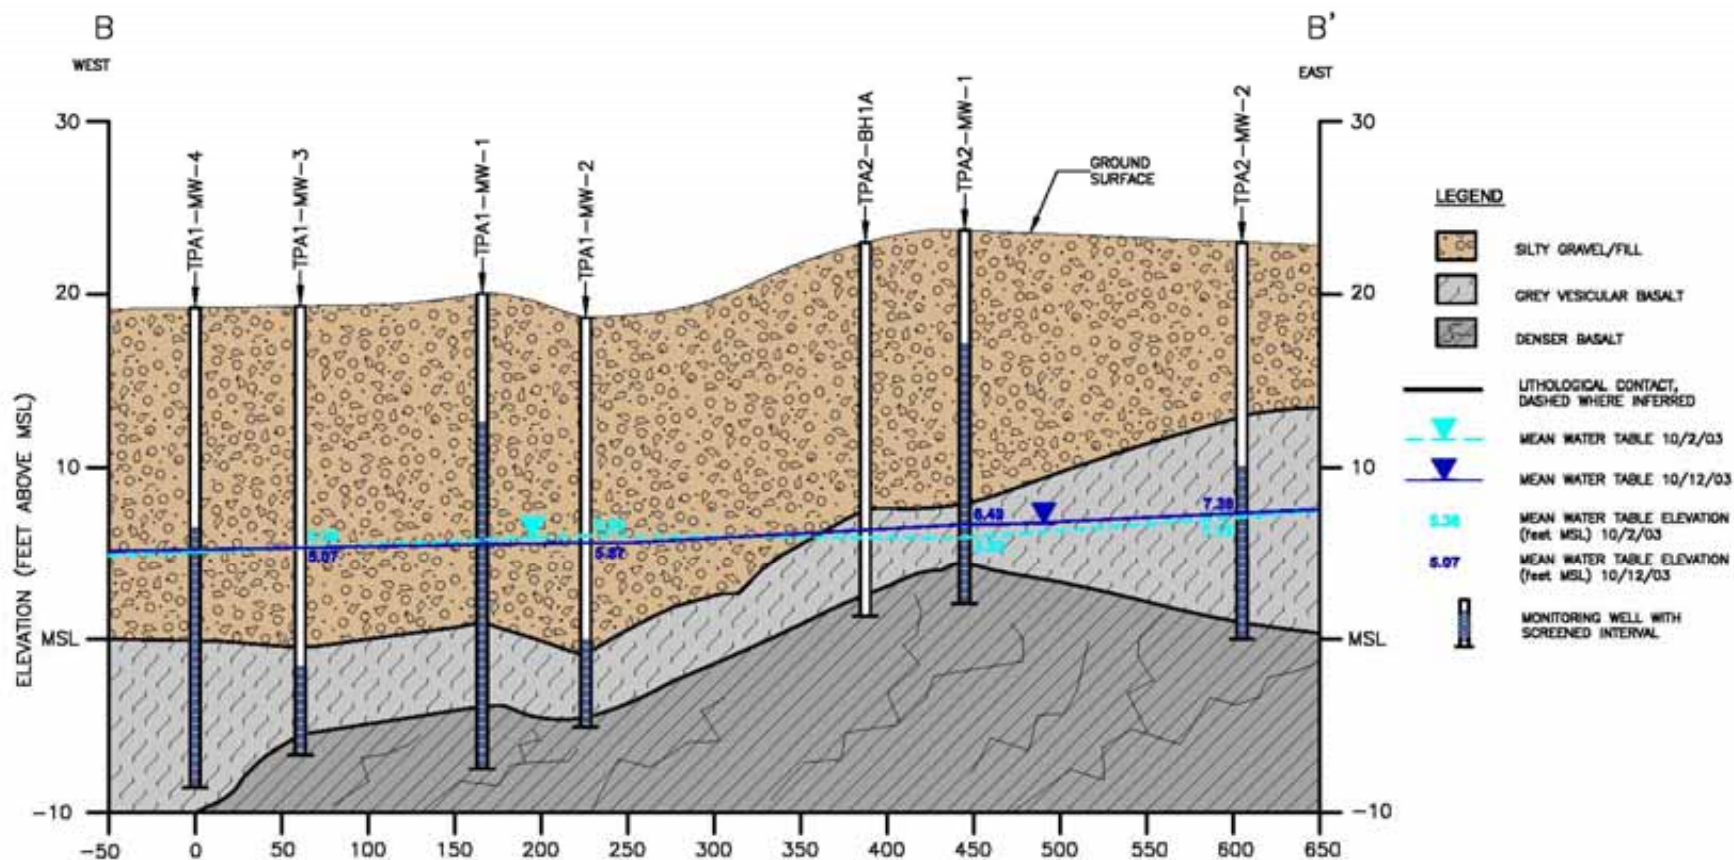
FIGURE 5-4

APPROXIMATE SCALE IN FEET
VERTICLE EXAGGERATION = 10X

GEOLOGIC CROSS-SECTION B-B'

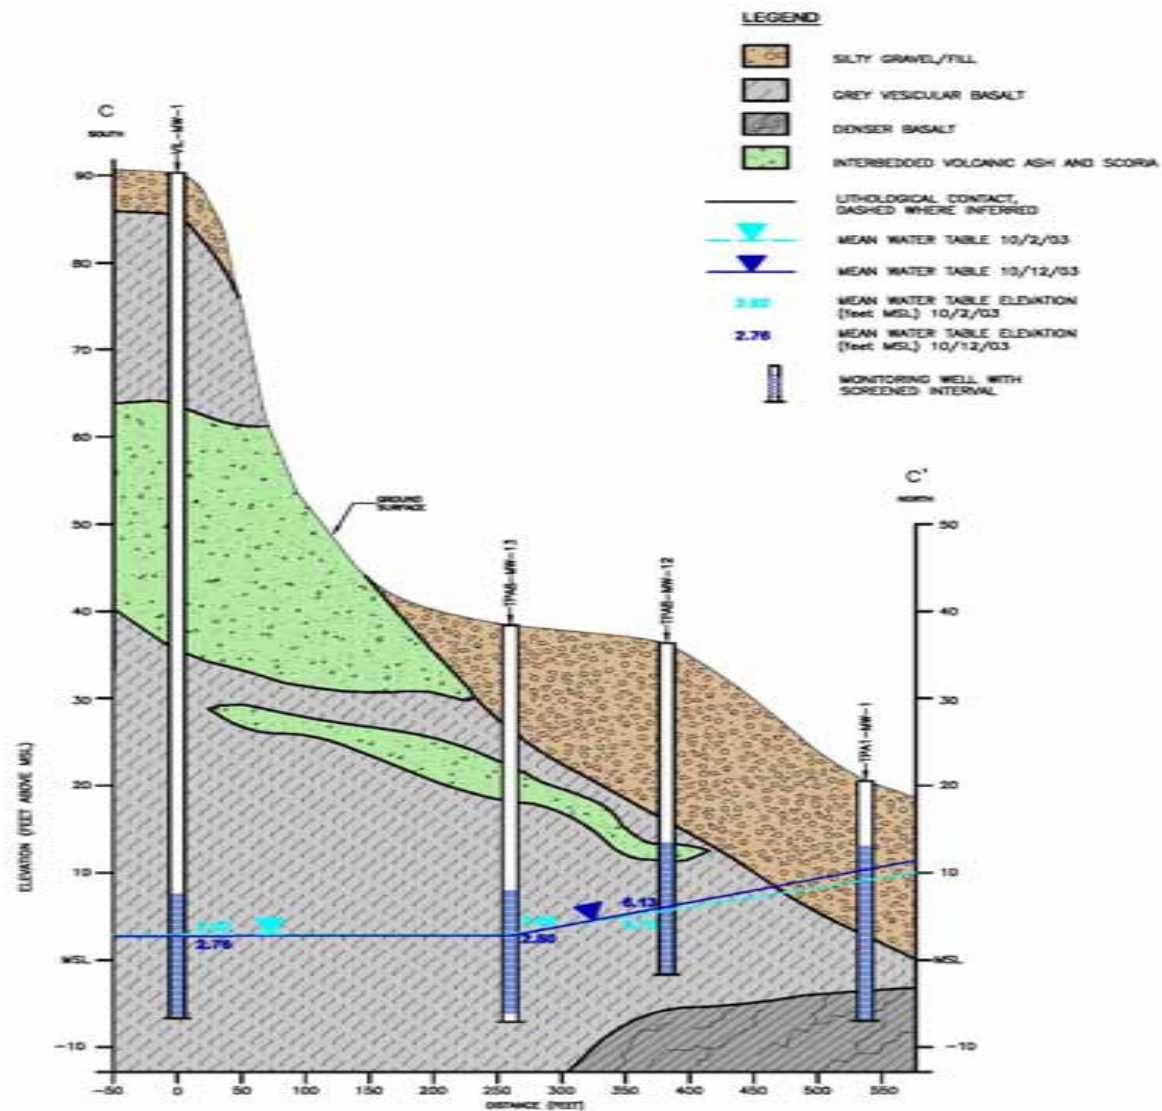
FIGURE 5-5

GEOLOGIC CROSS-SECTION C-C'

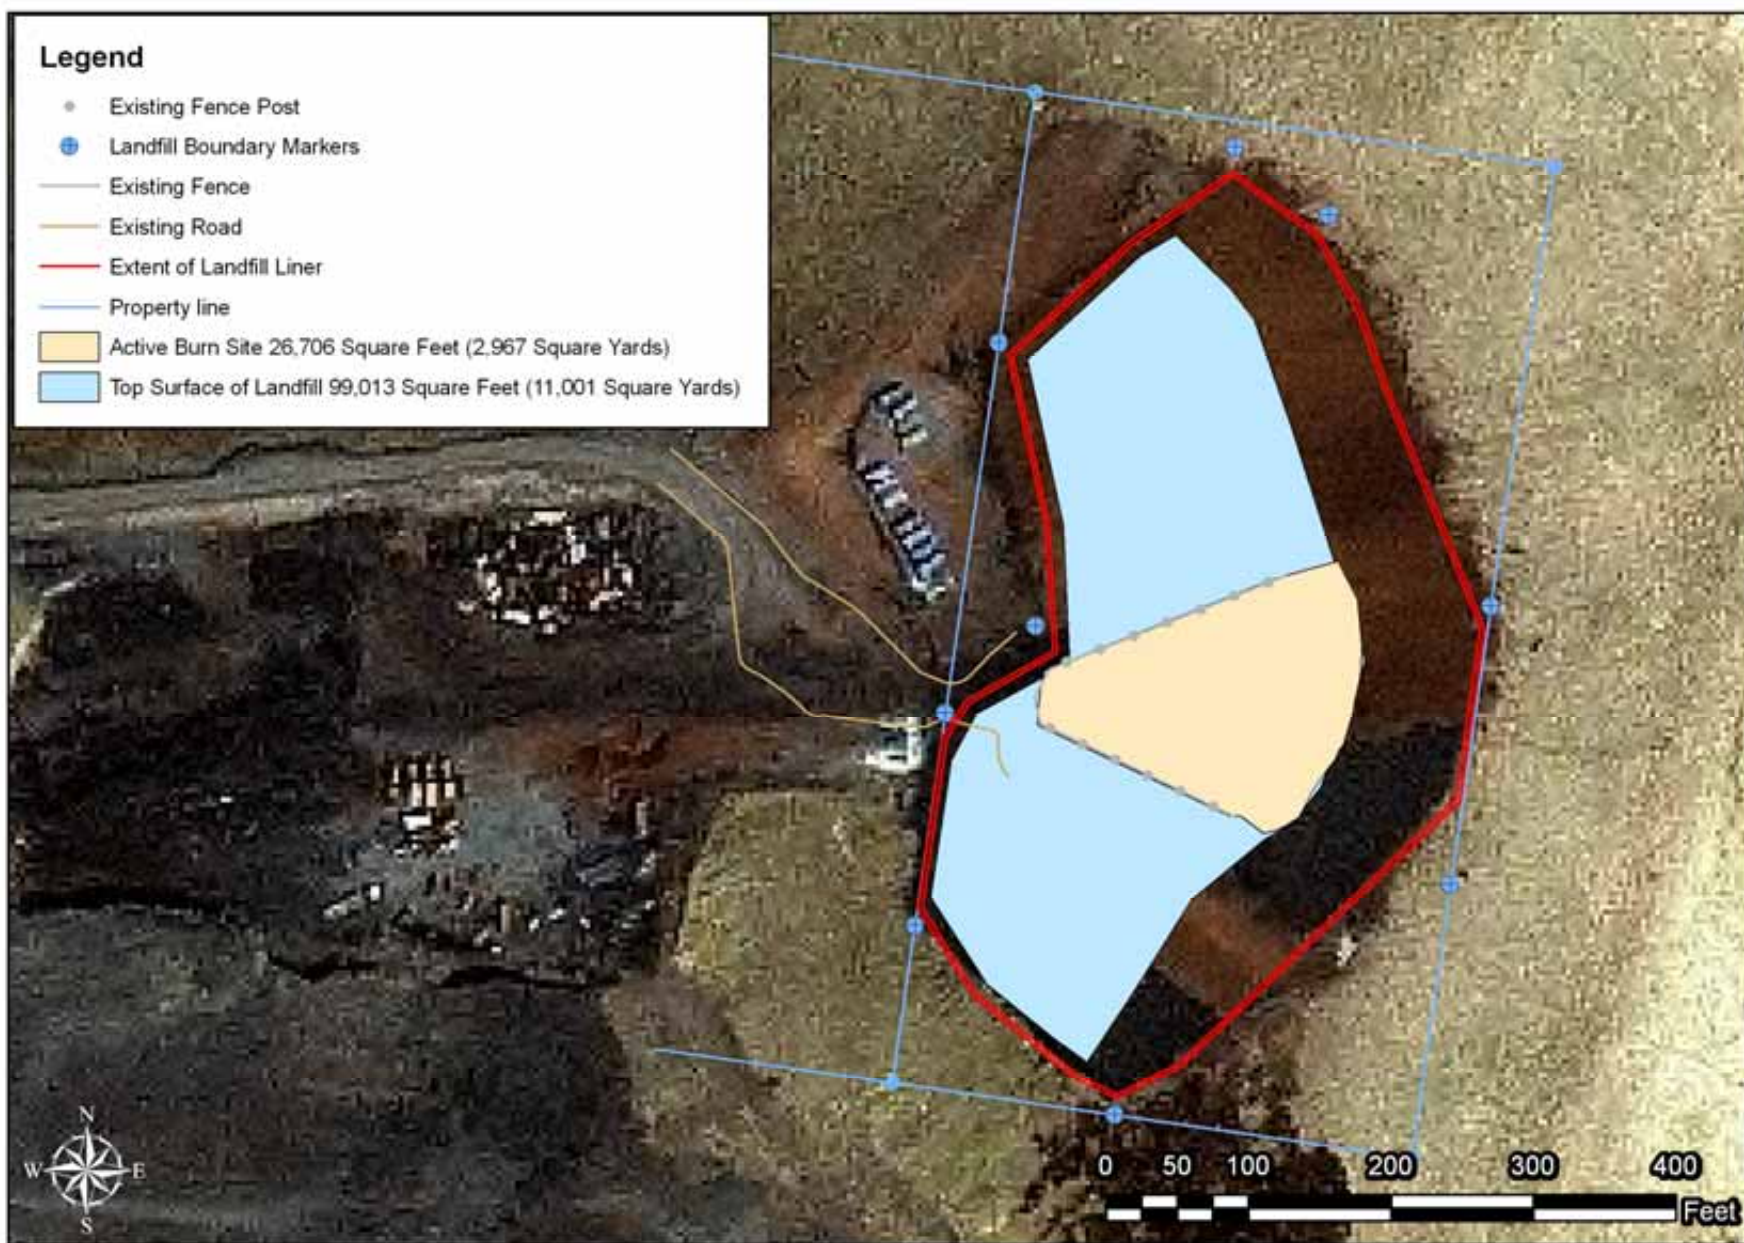
Figure

St. George Closed Landfill
TPA Site 4/NOAA Site 4
St. George Island, Alaska

Source: CE2 Engineers CAD Drawing;
Pribilof Project Database
